# CABLE DIAGNOSTICS IN SOUTH AFRICA

**Author & Presenter : Ronald H. Goodwin B.Sc(Eng)Elec, Natal  
Managing Director of H.V. TEST (Pty)Ltd.**

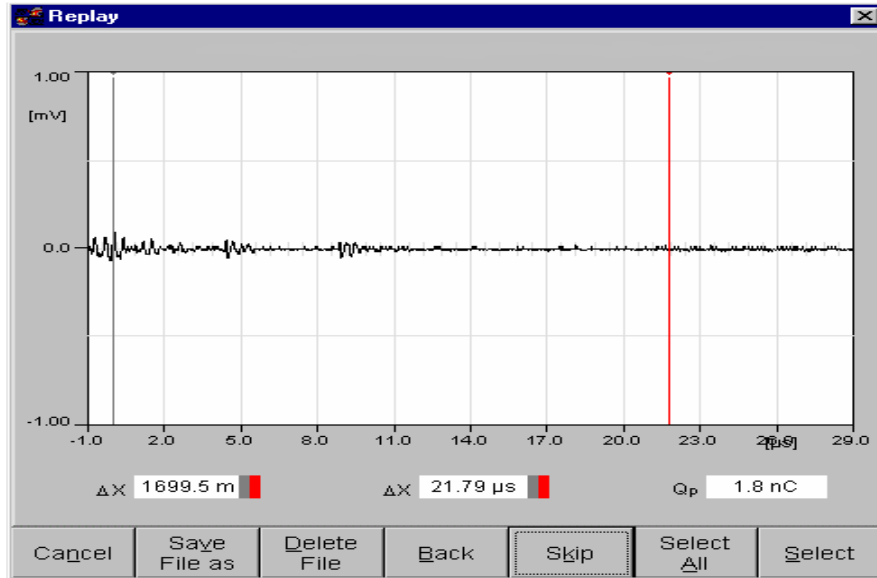
Partial Discharge occurs in a 11kV PILC cable as low as 3-4kV where levels of up to 50pc are easily seen at these low levels and after each PD discharge the cable “heals” itself using the impregnated oil/paper.

The discharge points are seen to normally move along the length of the cable and are not constant at one point.

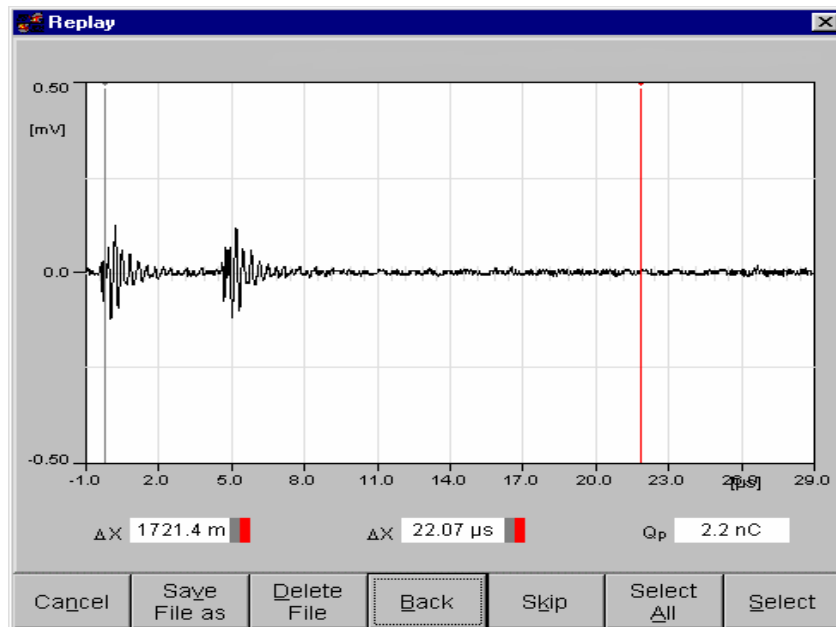
Where the PD activity at a point is seen to be consistent and above 1000pc (1.73U<sub>o</sub>) (at 0.1Hz) level, then this point should be investigated. A good example was where a PILC cable was diagnosed as having discharges at a specific point and this was found to be there was a sharp bend in the cable or in the case below, at a joint.

Faulty joint at 300m - Cable Length 1721.4m

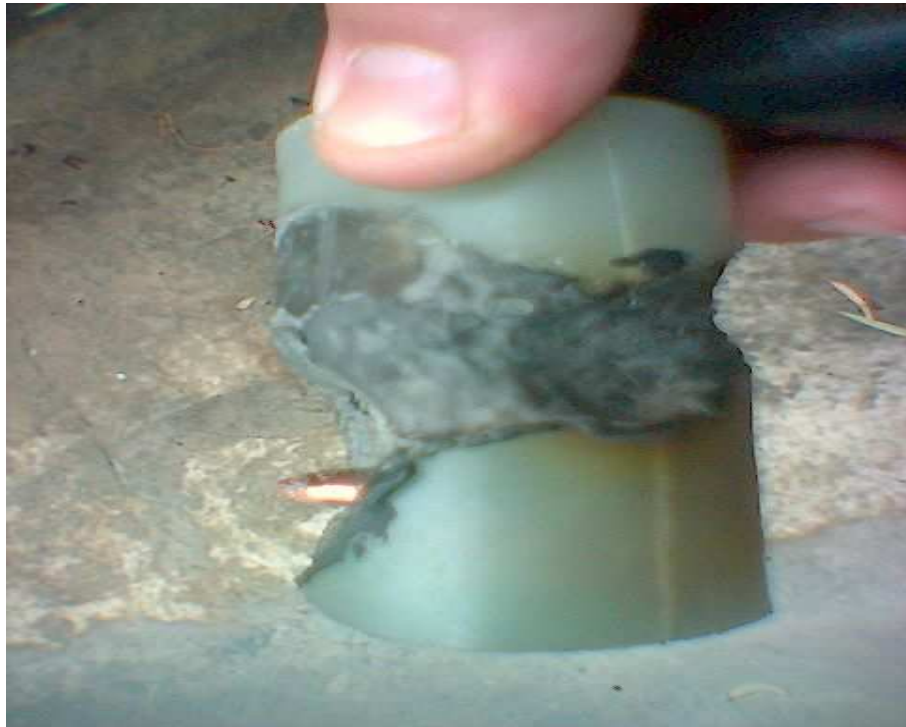
**Example of erosion of XLPE by PD and Copper tape interaction 33kV XLPE cable**
